**Hot/Wet Environmental Degradation  
of Honeycomb Sandwich Structure  
Representative of F/A-18: Flatwise  
Tension Strength**

DSTO-TR-0908

**Airframes and Engines Division  
Aeronautical and Maritime Research Laboratory**

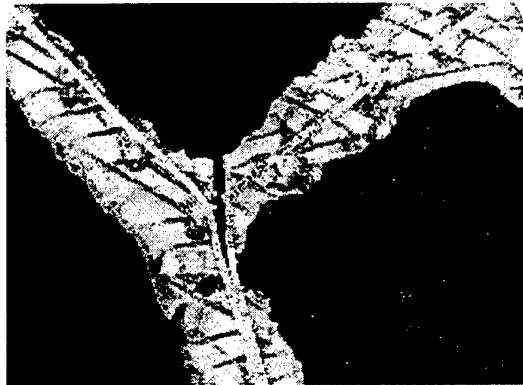
*Figure 15. Cracking through the skin to core fillet and into the node bond in a direct moisture ingress sample after 16 weeks exposure.*
